Manhole Inspection Summary

Manhole # S350__036MH

Insp Date: **1/22/09 2:50 PM**

Location Address: **800 s CHARLES ST**

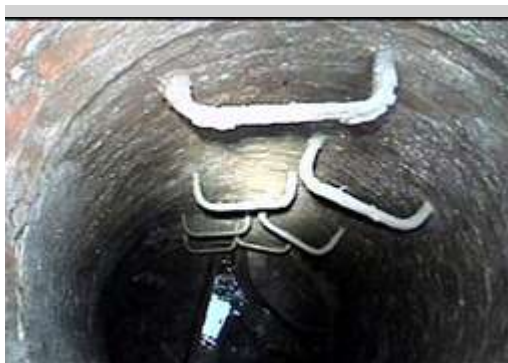
Defect 1

Count: **7** Missing: **0** ☒ **Corroded**

steps corroded

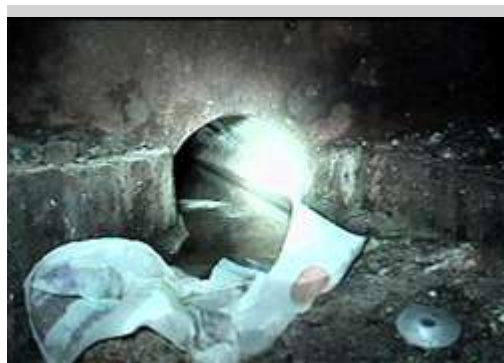
Defect 4

Condition: ☐ Sound ☐ Cracked ☐ Root Intrusion ☐ Deteriorated ☐ Leaks ☒ **Debris**

channel debris

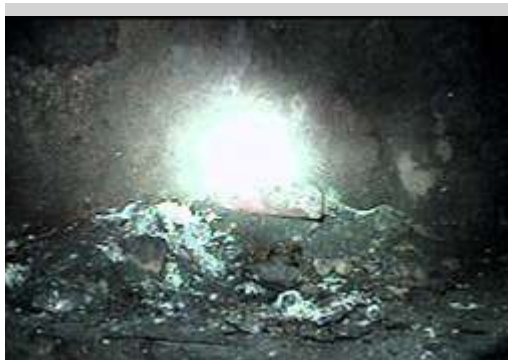
Defect 3

Condition: ☐ Sound ☐ Cracked ☐ Root Intrusion ☐ Deteriorated ☐ Leaks ☒ **Debris**

bench debris

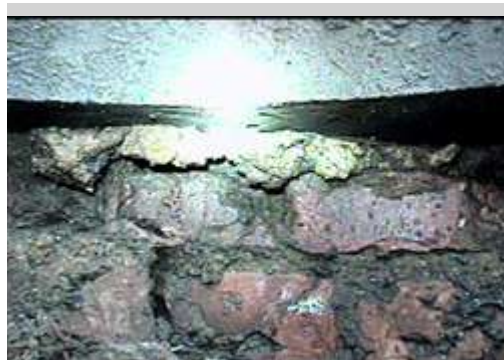
Defect 2

Condition: ☐ Sound ☒ **Cracked** ☐ Root Intrusion ☐ Loose Brick ☒ **Deteriorated**

chimney cracked deteriorated

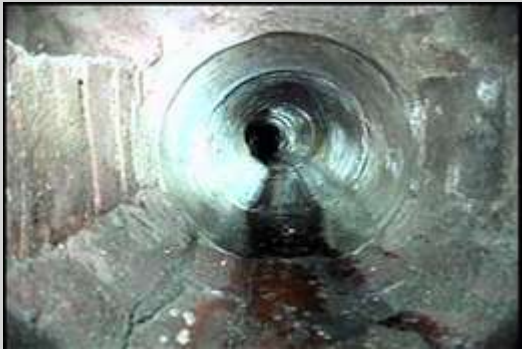
12 O'Clock Outflow

8 in. Circular Gravity Sewer
Pipe Out @ 12 O'Clock

Invert Depth: **12.25** (ft.) Flow Characteristics: **Slow**

Deposits: ☒ None ☐ Mud ☐ Sludge ☐ Debris ☐ Grease

Infiltration: **None** Pipe Seal Cond: **Unknown**

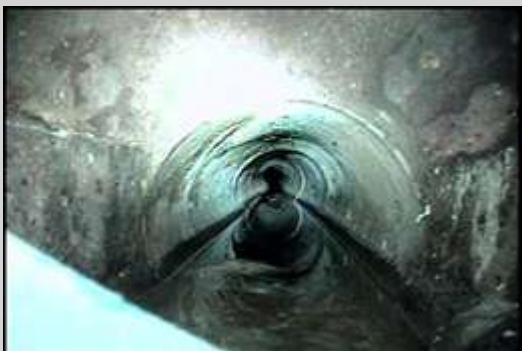
3 O'Clock Inflow

8 in. Circular Gravity Sewer
Pipe In @ 3 O'Clock

Invert Depth: **12.13** (ft.) Flow Characteristics: **None**

Deposits: ☒ None ☐ Mud ☐ Sludge ☐ Debris ☐ Grease

Infiltration: **None** Pipe Seal Cond: **Unknown**

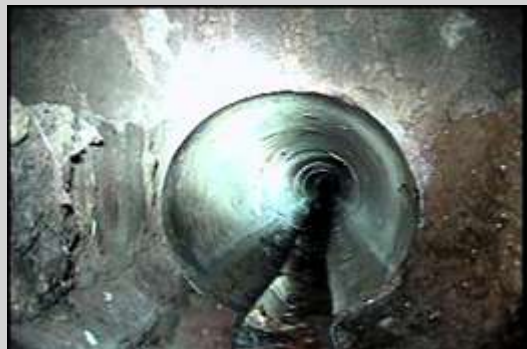
6 O'Clock Inflow

8 in. Circular Gravity Sewer
Pipe In @ 6 O'Clock

Invert Depth: **12.16** (ft.) Flow Characteristics: **Slow**

Deposits: ☒ None ☐ Mud ☐ Sludge ☐ Debris ☐ Grease

Infiltration: **None** Pipe Seal Cond: **Unknown**
